Manhole Inspection Summary

Manhole # S25K__015MH

Location Address: **300 McHenry St**

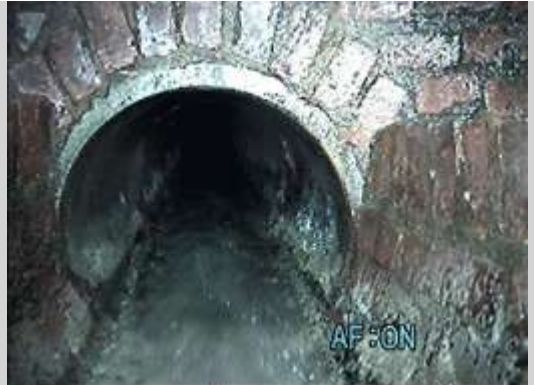
12 O'Clock Outflow

Pipe Height: **15.6** (in.) Rod and Bar (Angled)
Pipe Material: **Clay** ☐ Pipe Lined
Invert Depth: **16.90** (ft.) Flow Characteristics: **Fast**
Deposits: ☒ None ☐ Mud ☐ Sludge ☐ Debris ☐ Grease
Silt Depth: **0** (in.) Deposits Extent:
Infiltration: **None** Pipe Seal Cond: **Sound**

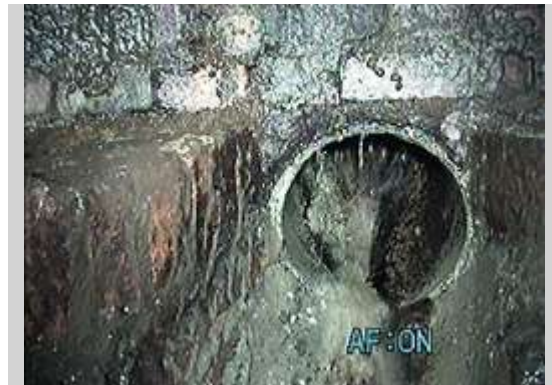
Drop In @ 4 O'Clock

Drop: **Outside** Rod and Bar
Angled: **Yes** Reading: **15.30** (ft.)
Inv Depth: **16.30** (ft.)
Drop Condition: **Open**

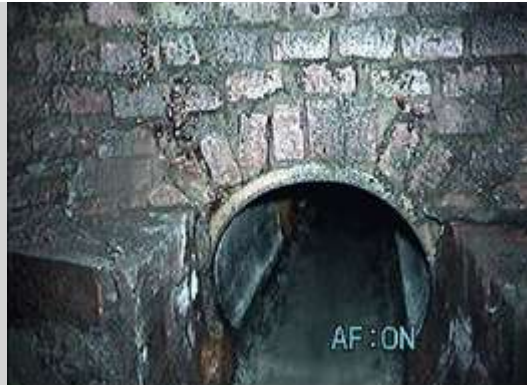
6 O'Clock Inflow

Pipe Height: **14.4** (in.) Rod and Bar (Angled)

Infiltration: **None** Pipe Seal Cond: **Sound**
